A community-based rainwater monitoring and treatment programme in Grahamstown, South Africa.

Abstract — South Africa is a water scarce country and its potable water supply suffers from problems such as pipe breaks and interruption of supply. This forces a large part of the population use rainwater for domestic consumption. In this climate, the current paper investigated the design of information tools about the source of rainwater contamination and the use of the modified hydrogen-sulphide test kit to detect the faecal contamination of rainwater. An information pamphlet was designed on the contamination sources of rainwater and the modified test kit was successfully used by the NGO volunteers to detect faecal contamination. The modified hydrogen-sulphide test kit and a combination of the *E. coli* enumerations correctly identified microbial water quality problems. These were then remedied using a collaboration between the authors and the community volunteers. The rate of correspondence between the m-TEC *E. coli* enumeration and the hydrogen-sulphide test kit was 71 %.

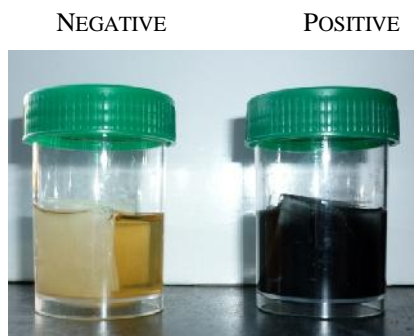
Figure 1. The illustration of the results interpretation of the hydrogen-sulphide test kit.

When the test is positive the water is not suitable for drinking without first boiling or treating with disinfectant. If the rainwater is being used for irrigation of food which is cooked before being consumed, then no actions needs to be taken, however if it is being used for drinking or washing then place 5 cm³ (for every 1000 cm³ of water) of sodium hypochlorite or JIK (not perfumed) into the tank. Never place more than 25ml into the tank. Allow the tank to stand unopened for at least 12 hours before using the water. Preventively add half a glass (150 cm³ of bleach) into a 5000 dm³ or standard rainwater tank once or twice a month.
